USACERL Special Report 96/19  
December 1995

# **The Barksdale Air Force Base Historic District**

## **Project Overview, History, and Maintenance Plan**

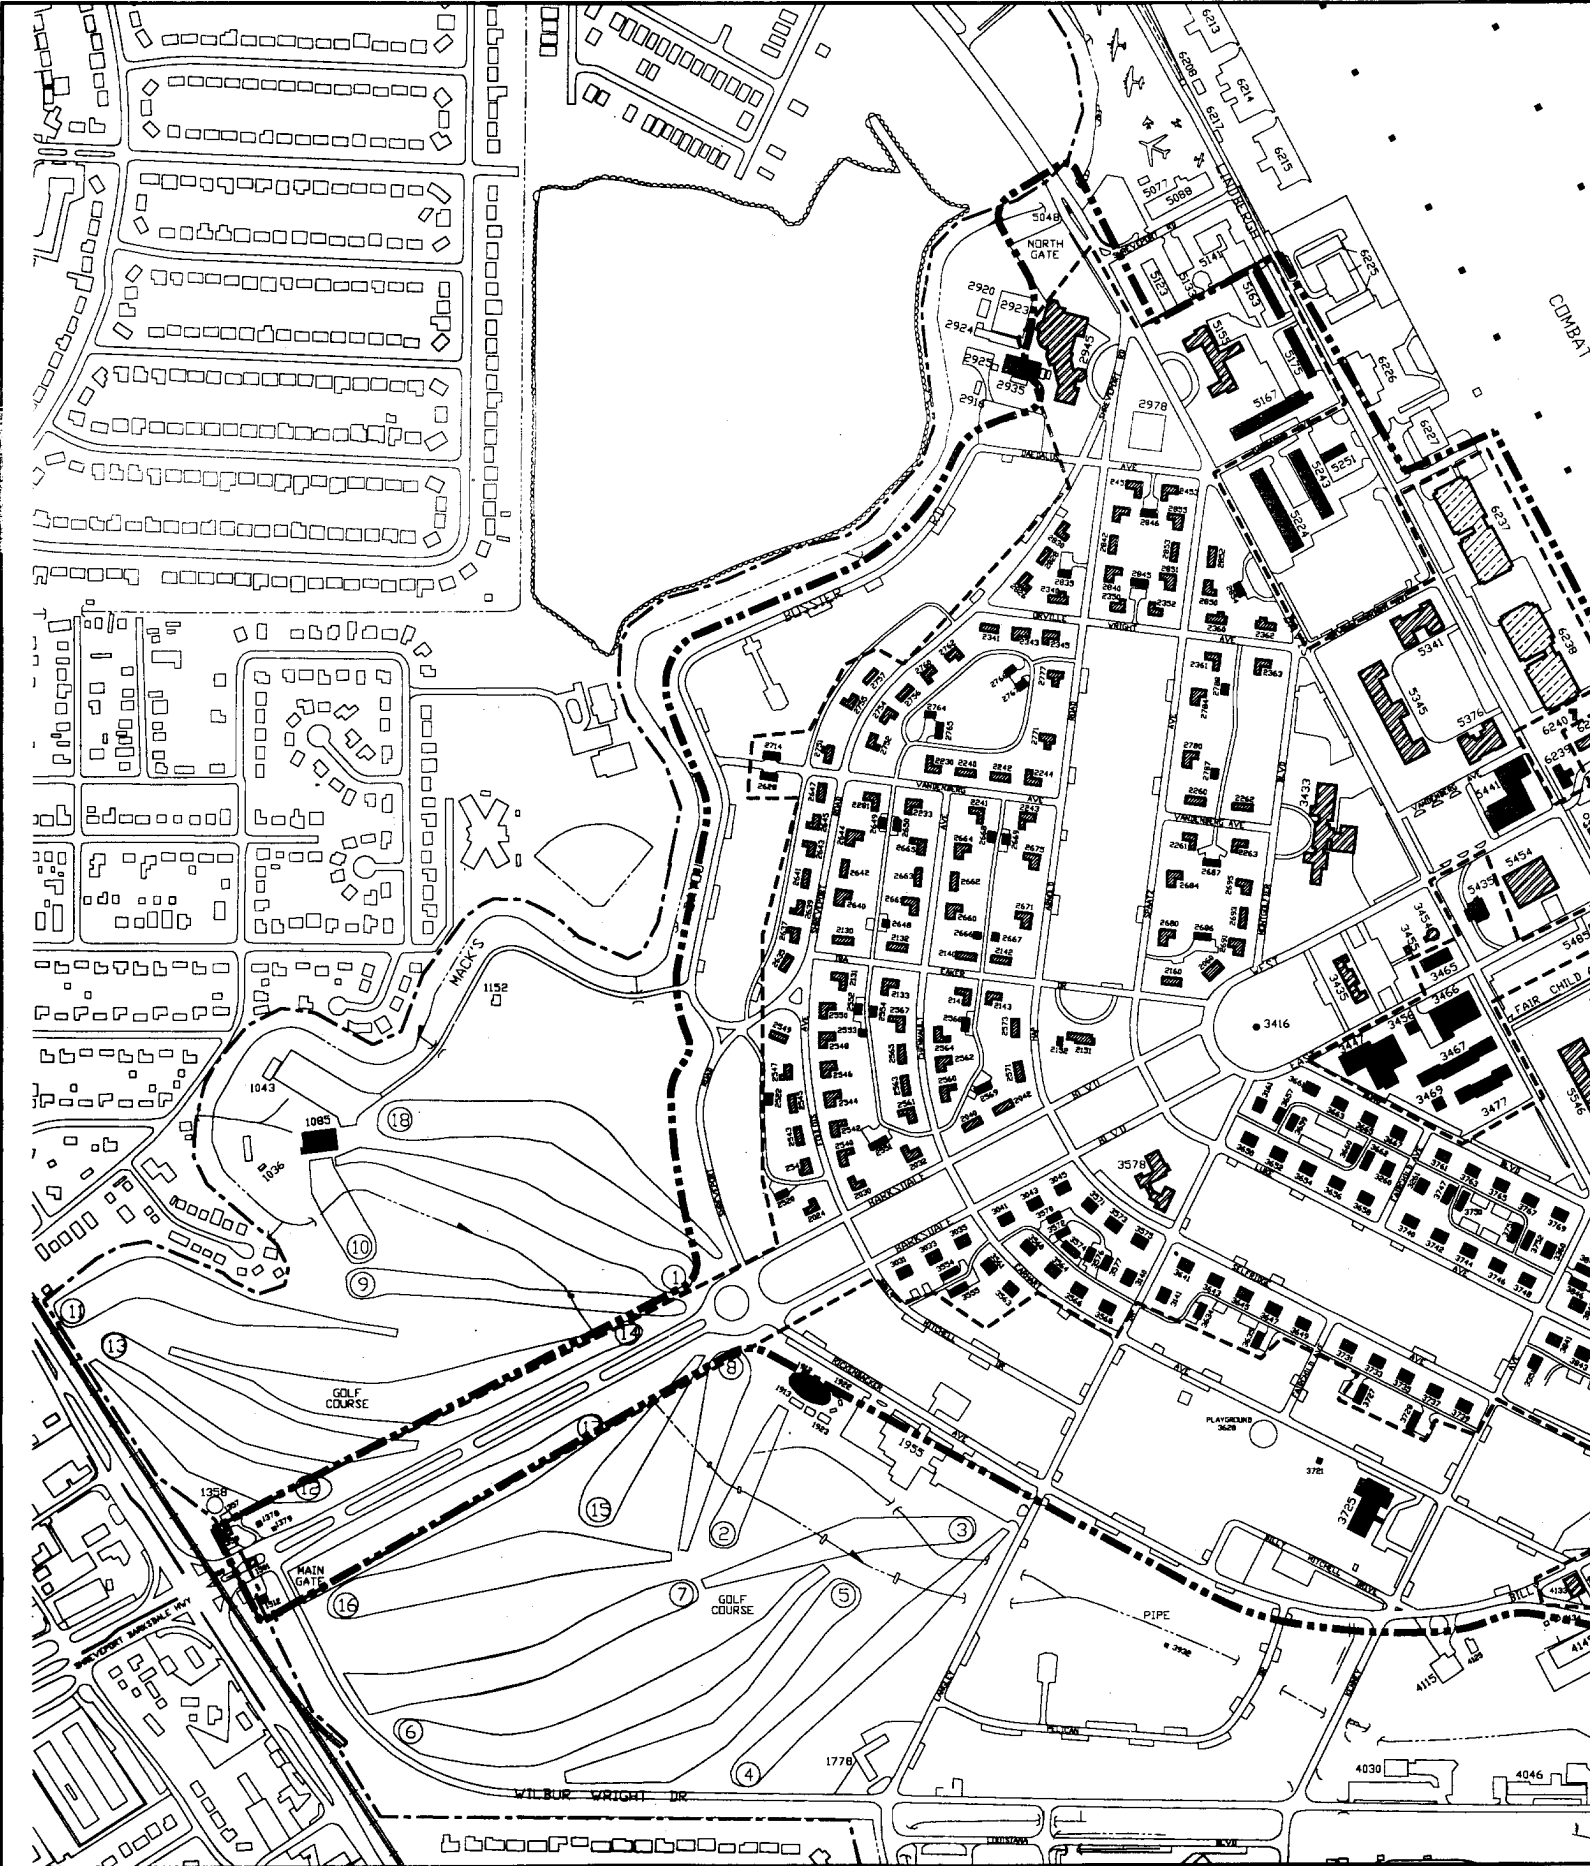
Figure 3. New district boundaries.

2. The HDMB follows along Bossier Road, Shreveport Road, around the West Gate, and back along Rickenbacker Avenue. This extends the original boundary of the historic district near the officer's housing, leaving the green space in between open for development. However, control of this green space will now be under the Cultural Resource Manager's jurisdiction. The existing radial plan and housing layout can be respected and expanded, compatibly adapting to the present historic district.

3. Building #4162 is now included within the district and #4186 is taken out. The HDMB follows these changes along Rickenbacker Avenue.
4. In creating a clearer boundary, the HDMB eliminates the "islands" of non-contributing buildings that existed with the former boundary. These buildings are now documented as being within the district, but non-contributing.

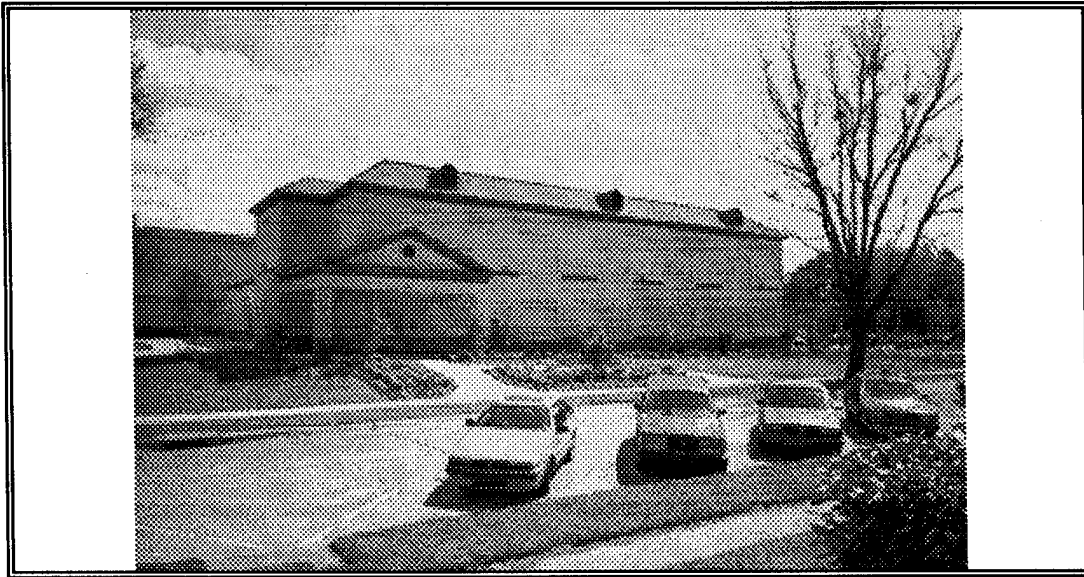
Flight Simulator Building, built 1983

Uses compatible Roof and Dormer types, as well as compatible Materials

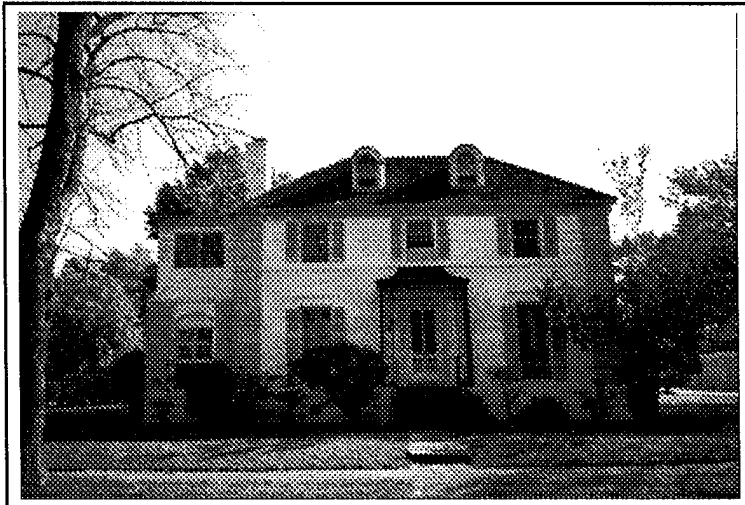
The Company Officer Quarters Type A single family houses were designed in the French Colonial Revival style. They are located throughout the officer housing area, and they are typically arranged in pairs, sometimes framing other buildings. Constructed of terra-cotta block bearing walls on a concrete foundation, the houses contain two stories, an attic, and a crawl space. The main mass of the buildings consists of an L-shaped two-story block with an additional one-story wing on the rear. The building facades are symmetrical except for the two-story porch wing set back on either the left or right side. Both levels of the side porch wing are now enclosed. An open entry porch projects from the center of the front facade.

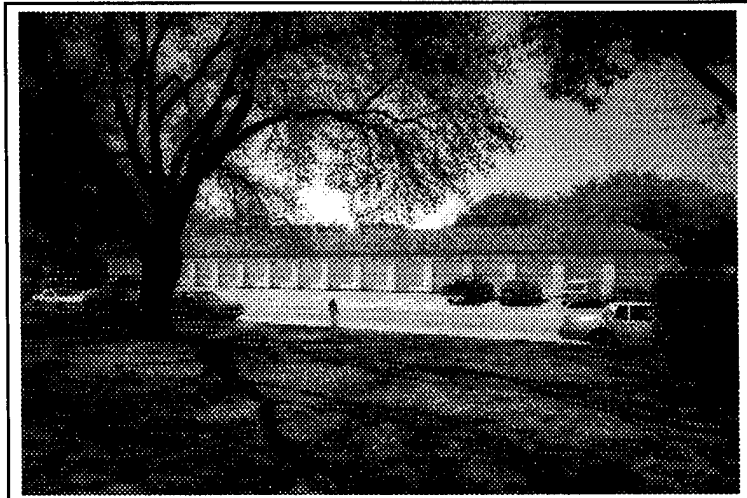
This garage for family housing is one of many similar outbuildings in the historic district. The structure is one story, constructed of terra-cotta block walls on a concrete pad foundation. The exterior is stucco with a hipped roof that matches the French Colonial Revival styling of the historic district. The roof is asphalt shingle, which has replaced the original clay tile. The original gutters and downspouts have also been removed. Steel overhead doors have replaced the wood panel doors, and the metal casement windows to the rear, where extant, are original. The roof is trimmed with a wood cornice, and the windows have cast concrete sills. Exterior lighting and fuse boxes have been added. The interiors are intact and are distinguished by an open wood truss ceiling, glazed terra-cotta block walls and a concrete floor. The rectangular building varies as to how many bays it contains, depending on the location and the number of families it serves. There two 17-bay garages. They were built to service the Bachelor Officer's Quarters and are now storage space.

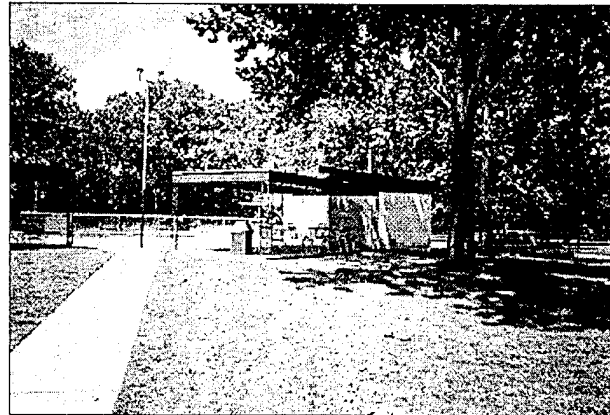
### Front Elevation

This structure has had many alterations since it's completion in 1938.

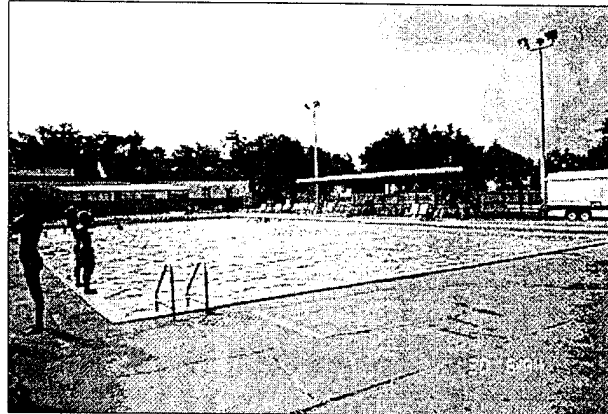
**Front Elevation**

This structure is basically in it's original state, but does not contribute to the visual make-up of the historic district.

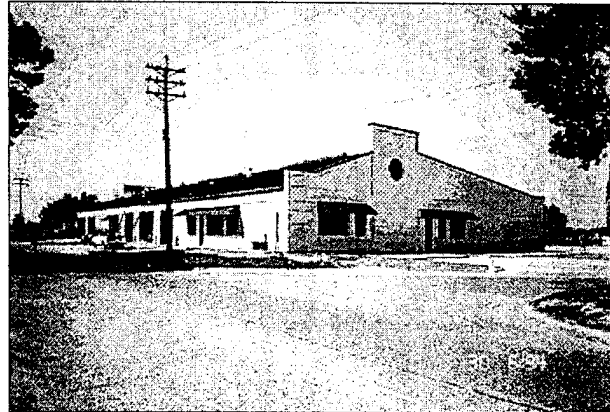
**Front Elevation**

This building was completed as an Air Corps Garage in 1941. Recent alterations in progress as of 7/19/94 have compromised the historic integrity of the building. The original asbestos sheeted roof had been replaced with asphalt shingle and has now subsequently been replaced by a standing seam metal roof. The building enclosure, originally of stucco finished hollow terracotta tile is now being covered with Dryvit. Window locations have been altered and have been replaced with brown anodized aluminum windows. Standing seam metal canopies now cover these windows. Major additions made of concrete block and Dryvit have altered the original plan and elevations.

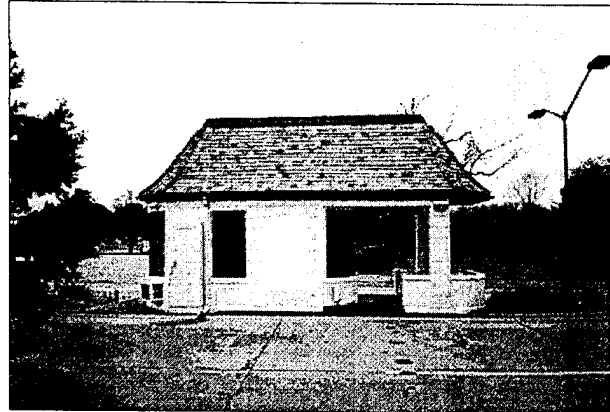
Front Elevation

This structure was completed in 1935 and presently serves its original function. It has undergone many alterations which have compromised the structure's historic integrity. The gates have been completely removed. An additional porch was created changing the proportions of the original structure. A window was filled in, and remaining windows have been changed from wood multi-light fixed windows to non-compatible brown anodized aluminum single light fixed windows. Also a single light door of non-compatible brown anodized aluminum was added into the window arrangement on the rear of the guard house.

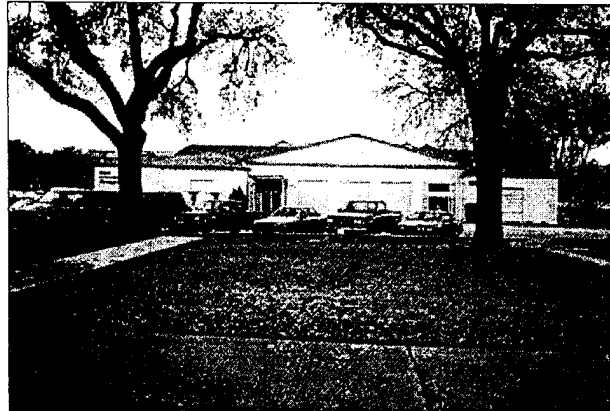
### Front Elevation

Originally, the floor area was 8683 square feet. Subsequent lean-to additions built before 1941 have gained historic significance. The original building was rectangular in plan with the main elevation facing what is now Barksdale Blvd W. The front elevation had two pavilions flanking a colonnade that had formed the front porch of the Postal Exchange. The pavilions had flat clay tile hipped roofs and the colonnade had a flat roof with parapet wall. The main space was spanned by a flat clay tile gambrel roof. The original windows were 8 light casements with a multi-light transom, and the doors were one panel wood multi-light.

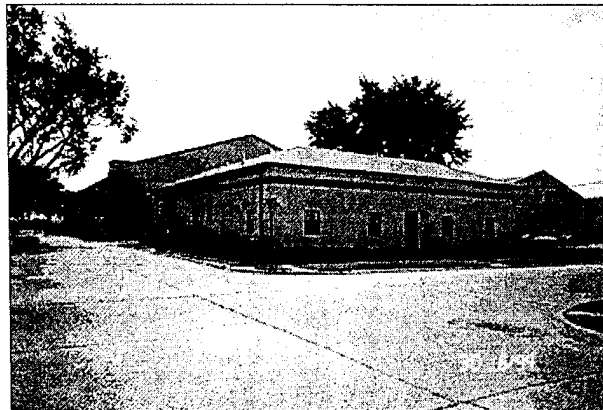
### Front Elevation

This building was completed in 1940. It subsequently has undergone many alterations which have compromised the structure's historic integrity. The window and door openings were dominant elements on the building enclosure. These openings have been compromised by being partially filled in and replaced by smaller, non-compatible brown anodized aluminum units. Also, the roof (original material not known) has been completely redone, being replaced by non-compatible asphalt shingle.
